Pollution Liability Insurance Agency

Commercial Underground Storage Tank Loan and Grant Program

Quick Stop#4 Longview, Cowlitz County, Washington

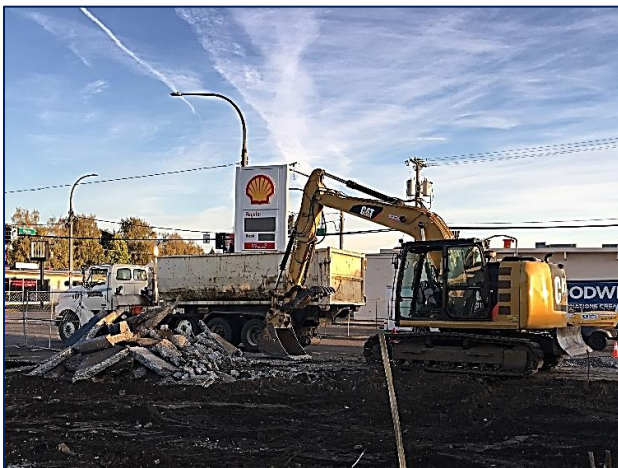
Removing concrete above USTs. Photo credit: Vertex.

Construction began in October 2019. Five USTs and 3,873.56 tons of contaminated soil were removed. Efforts also included pumping contaminated groundwater out of the tank pit at the time of tank removal. Remaining pollution in groundwater is decreasing and continues to be monitored quarterly until the state cleanup levels are met.

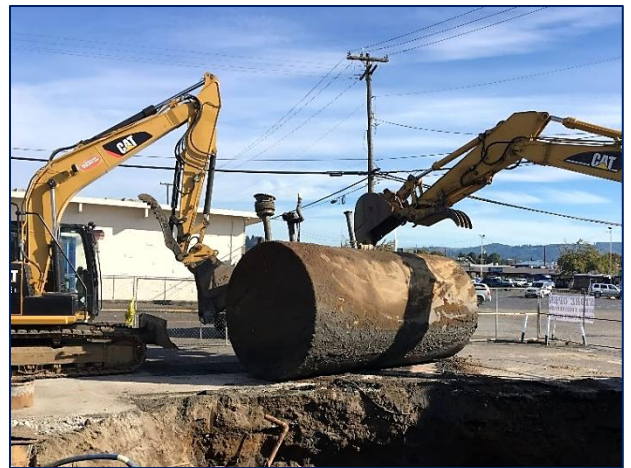
Removed diesel tank. Photo credit: Vertex.

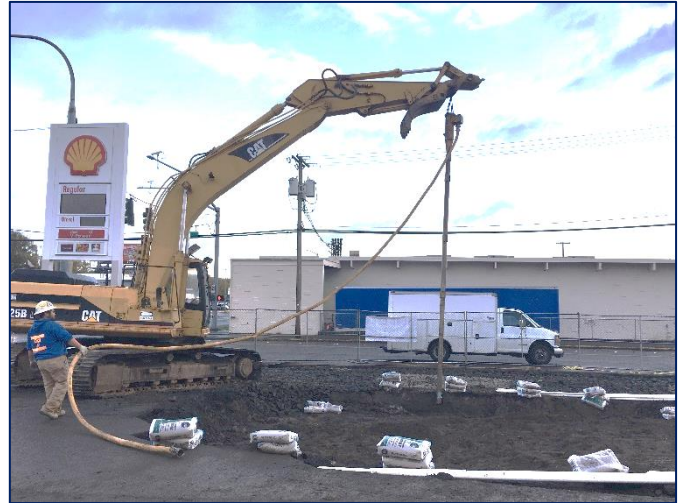
Installation of wells for groundwater extraction. Photo credit: Vertex.

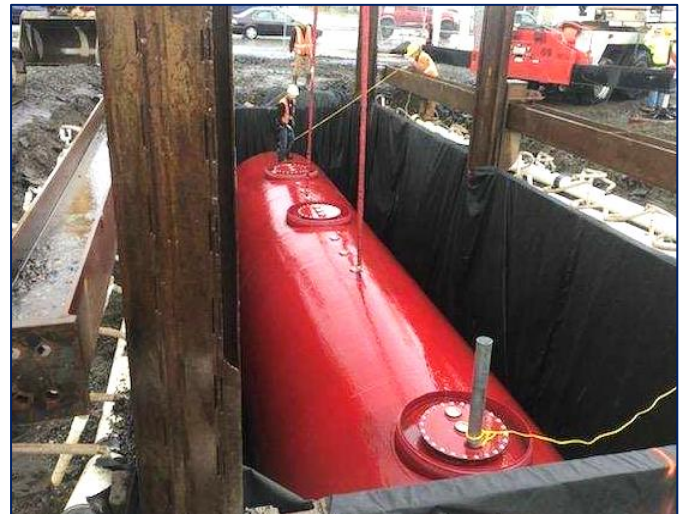
Installation of new multi-chambered UST. Photo credit: Vertex.

- Installation of a new, 22,000-gallon, double steel wall tank with 3 compartments and a fiberglass coating.
- Double wall piping.
- A new canopy.
- An electric vehicle charging station.

The new tank has been installed and re-fueling operations resumed in summer 2020.
